Case study on **JAL -516** crash Jan 2, 2024

DR.M. ELANGOVAN

DEPARTMENT OF AEROSPACE ENGINEERING

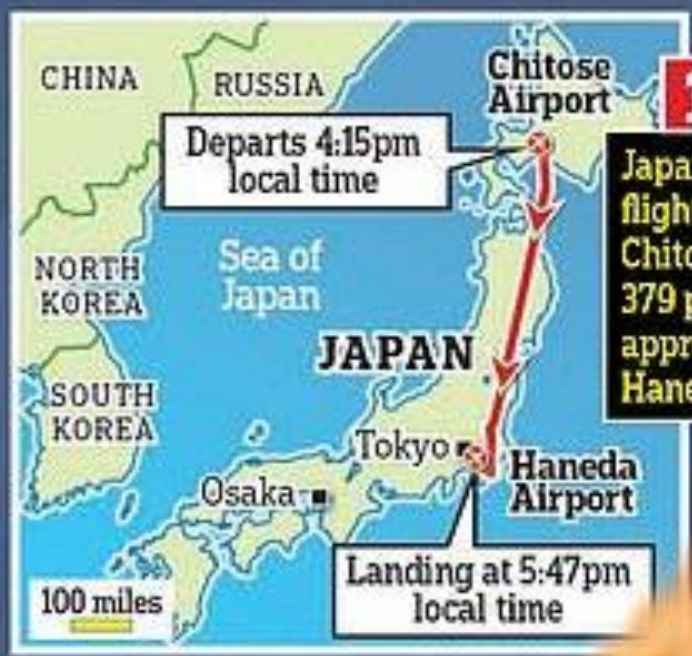
HOW DISASTER UNFOLDED

Departs 4:15pm local time

1
Japan Airlines flight 516 from Chitose, carrying 379 passengers, approaches Tokyo Haneda Airport

Landing at 5:47pm local time

4
The Airbus A350 bursts into flames and skids down the runway

2
Passenger jet collides with a coastguard plane that is preparing to take off on the same runway

3
Five of the six crew members on the coastguard plane are killed

5 All 379 passengers and crew from the Airbus manage to escape

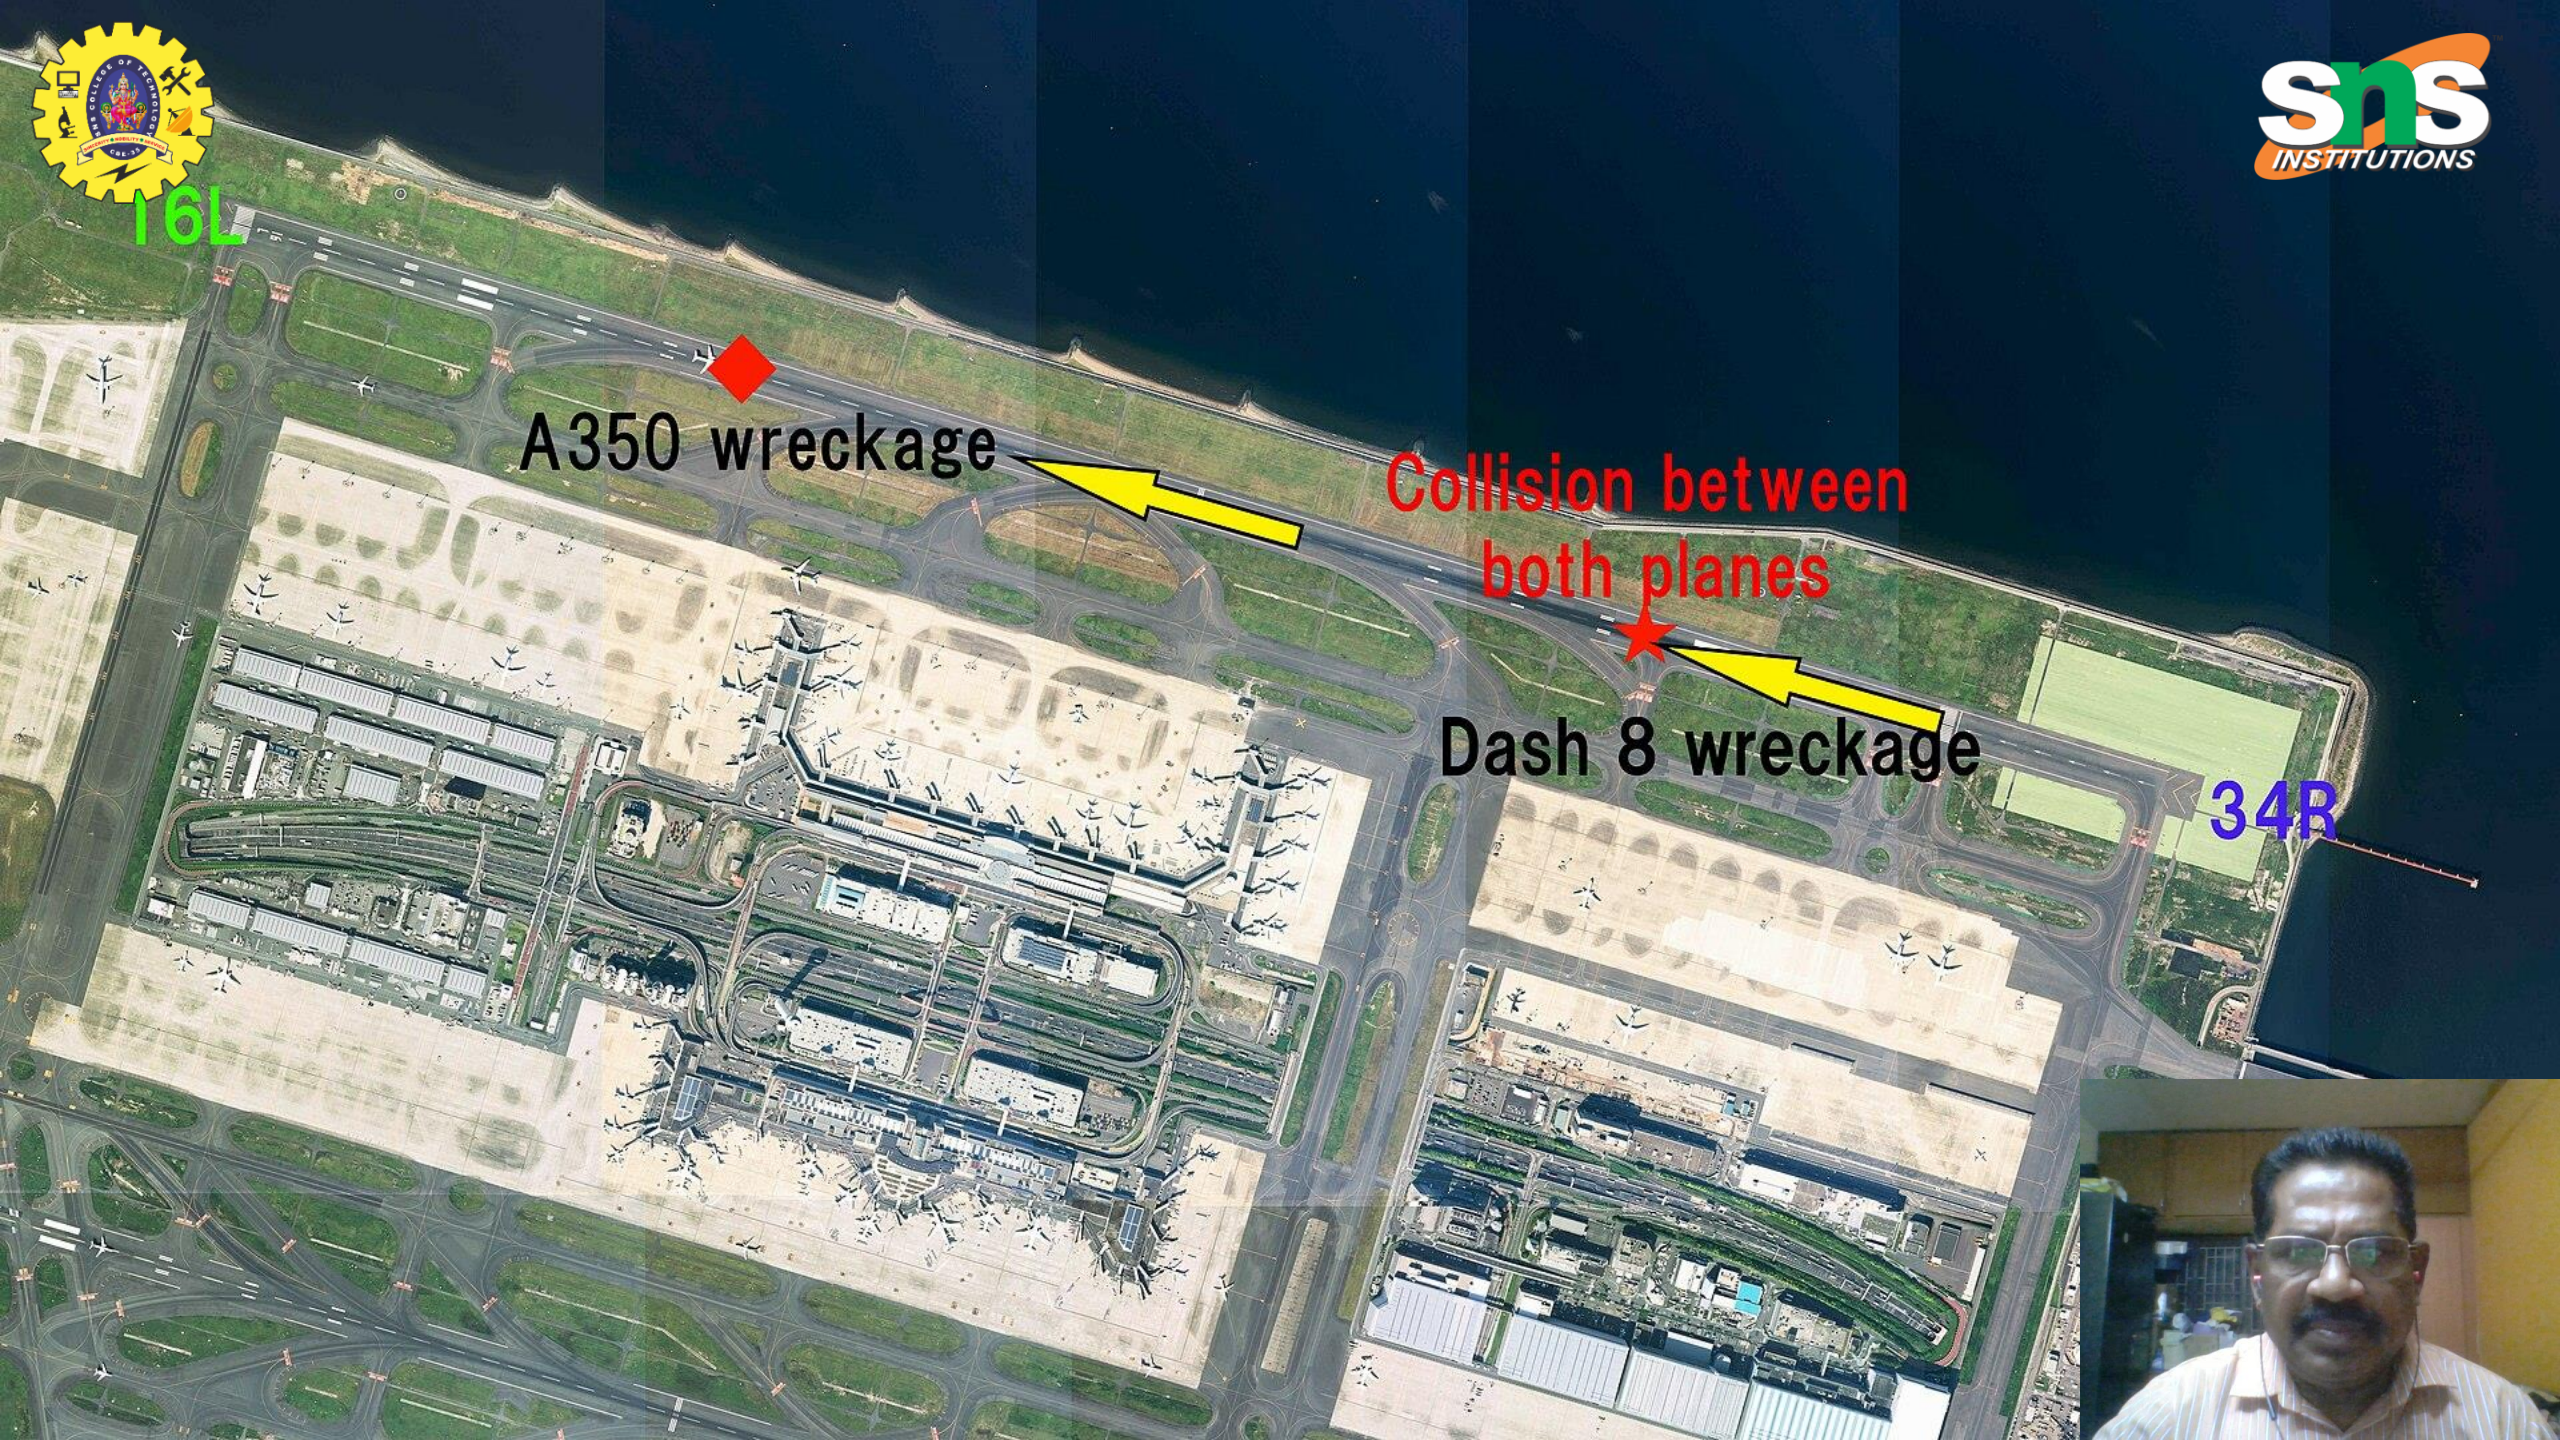
A350 wreckage

Collision between both planes

Dash 8 wreckage
