SNS COLLEGE OF ALLIED HEALTH SCIENCES

DEPARTMENT OF CARDIAC TECHNOLOGY-II YEAR

UNIT IV : ECHO ASSESSMENT OF PROSTHETIC VALVE

Echocardiographic Evaluation Of Prosthetic Cardiac Valves

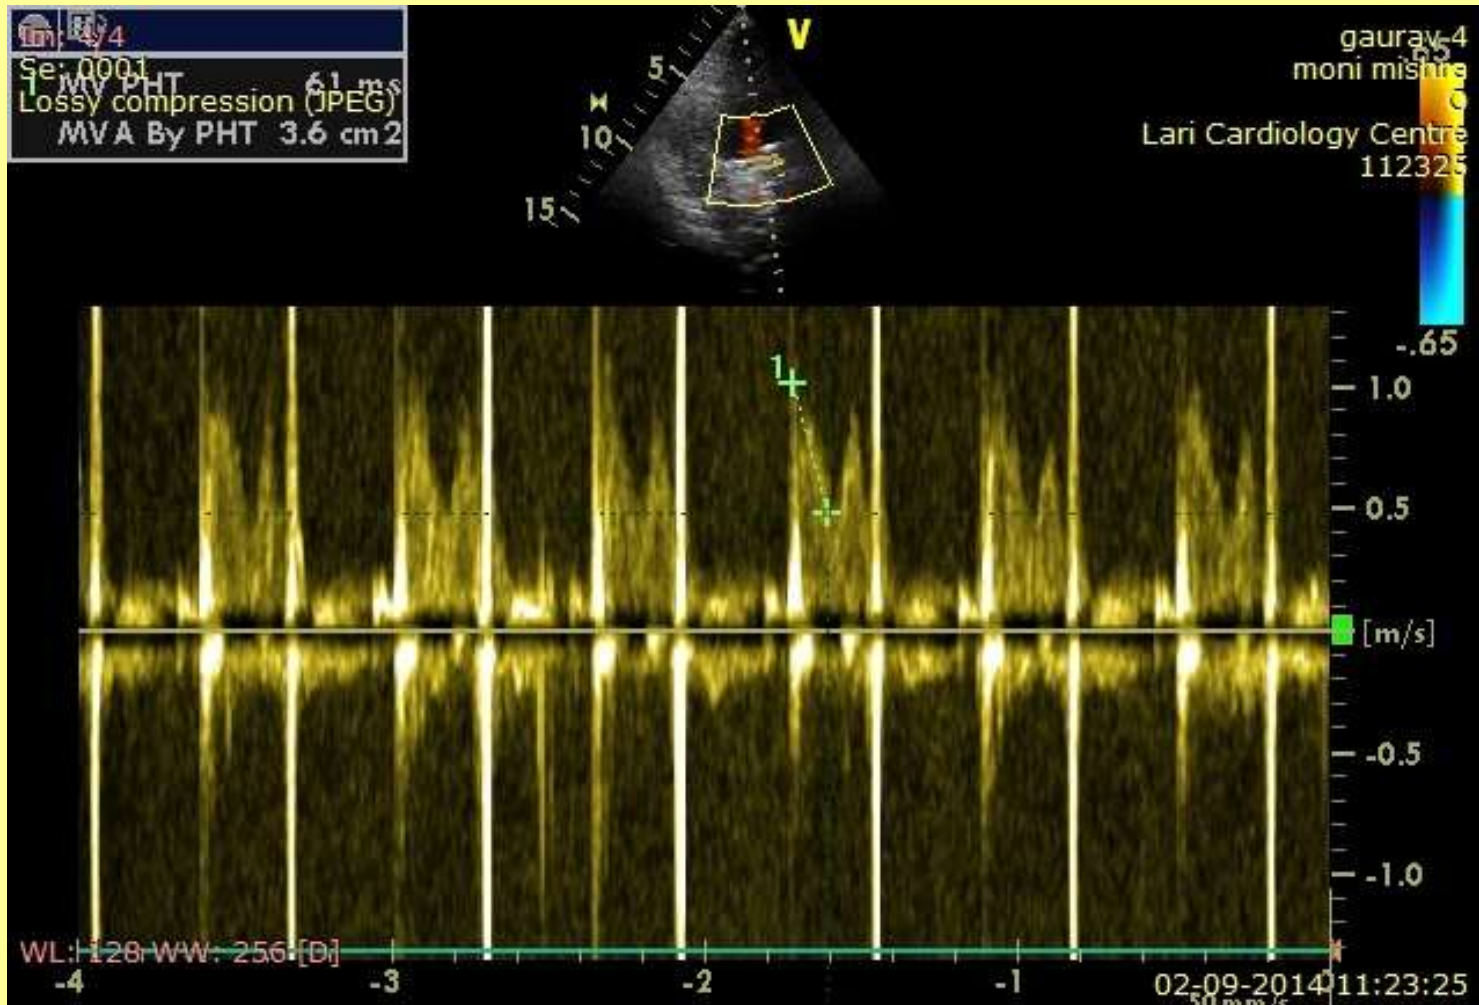
MVA = 3.6 cm²

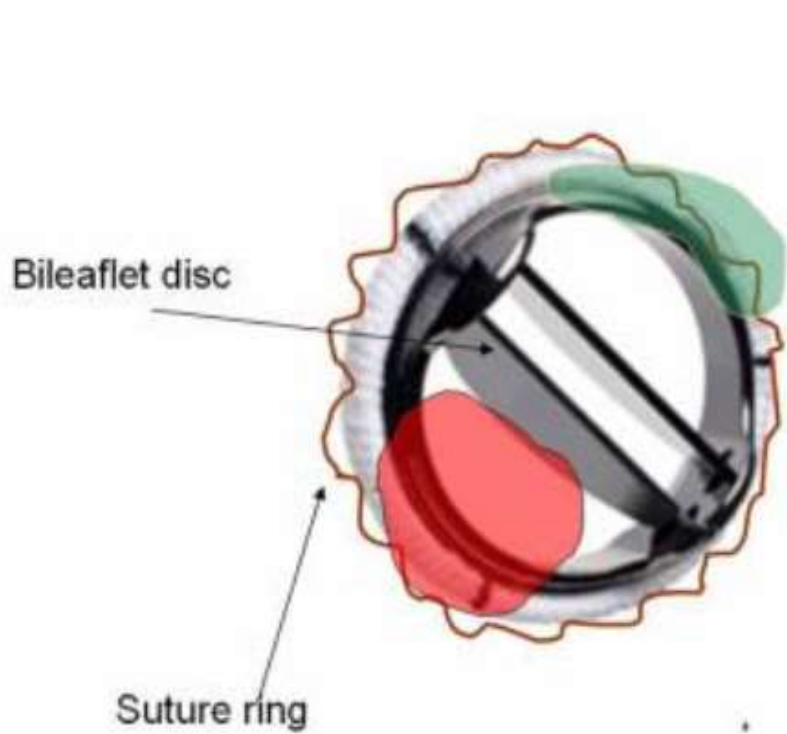
Prosthetic valve thrombus and pannus

Bileaflet disc

Suture ring

Pannus

- Small, less dense mass, growing from
- Within suture line
- Along the plane of valve

Thrombus

- Large
- Less dense
- Mass project away from valve disc

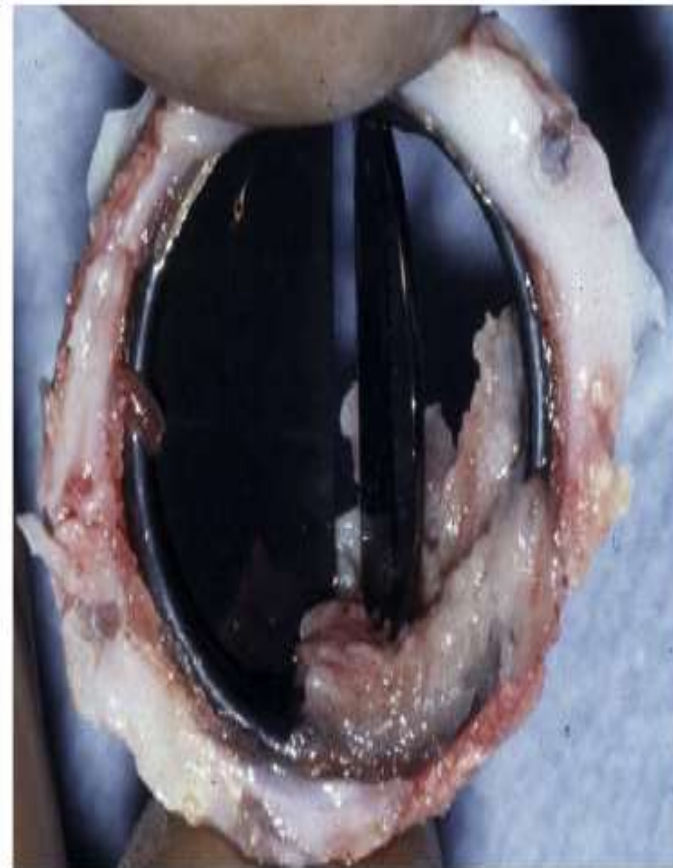
Figure 5 Pannus formation on a St. Jude Medical valve prosthesis in the aortic position as depicted by TEE. The mass is highly echogenic and corresponds to the pathology of the pannus at surgery. The pannus is depicted by the arrows. LA, Left atrium; LV, left ventricle.

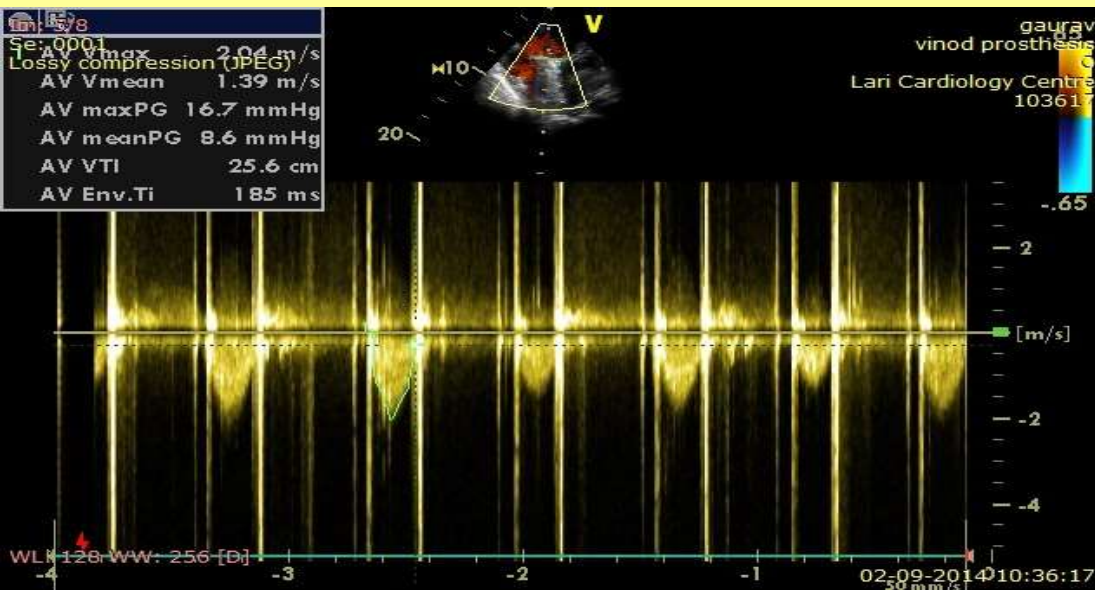
Velocity at prosthetic valve level 2m/s

DVI = 1/2 = .5

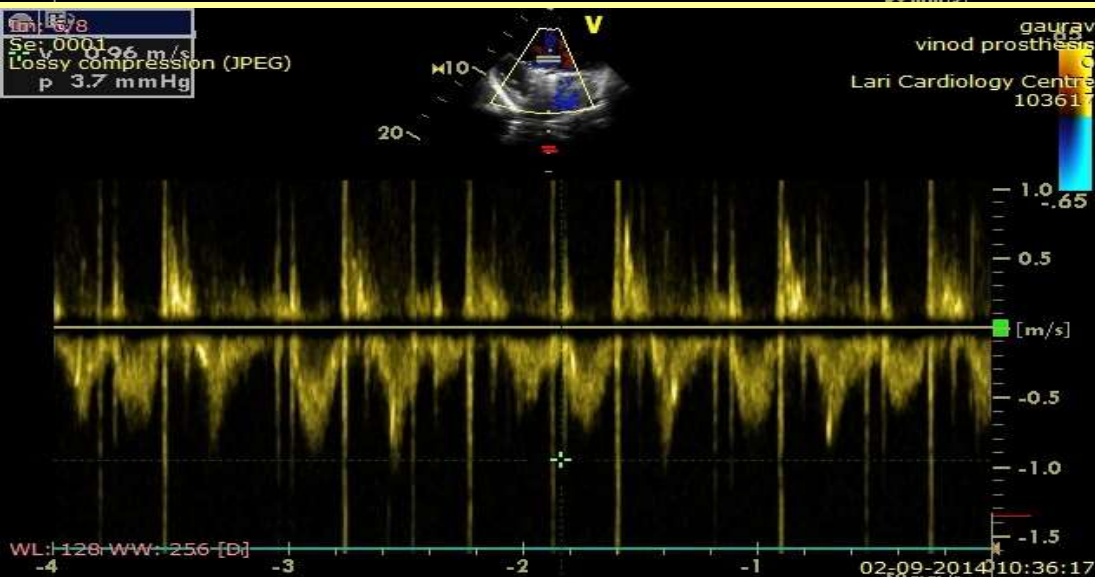
Velocity at LVOT level 1m/s

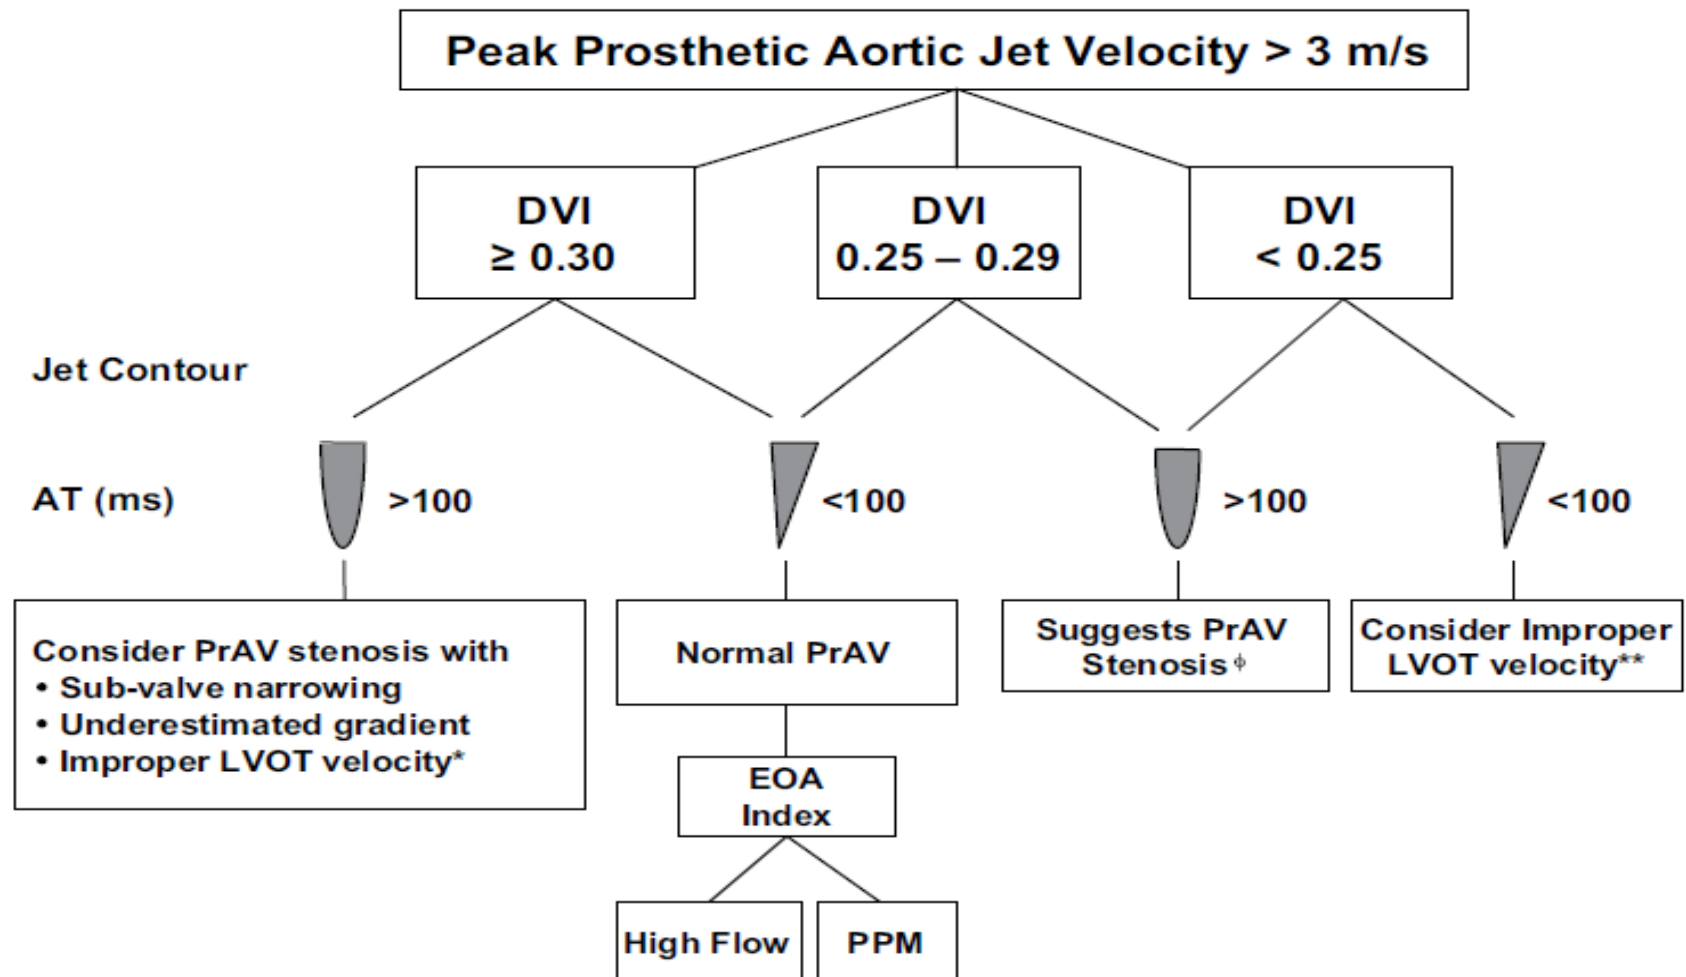
Figure 10 Algorithm for evaluation of elevated peak prosthetic aortic jet velocity incorporating DVI, jet contour, and AT. *PW Doppler sample too close to the valve (particularly when jet velocity by CW Doppler is ≥ 4 m/s). **PW Doppler sample too far (apical) from the valve (particularly when jet velocity is 3-3.9 m/s). ^φStenosis further substantiated by EOA derivation compared with reference values if valve type and size are known. Fluoroscopy and TEE are helpful for further assessment, particularly in bileaflet valves. AVR, Aortic valve replacement.

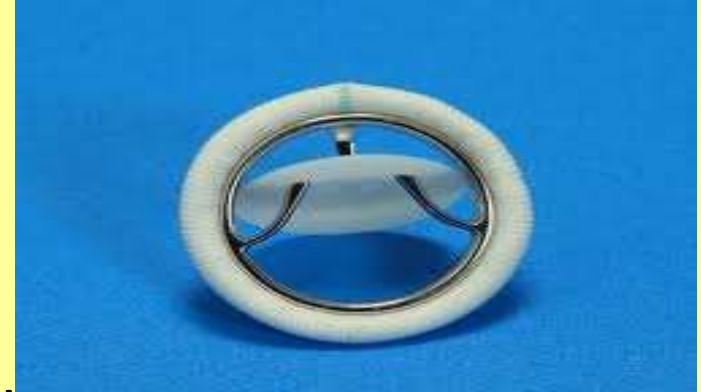
TTK chitra valve

- Tilting disc valve
 - Metallic housing (cobalt based wrought alloy)
 - Circular disc high molecular weight polyethylene
 - Polyester suture ring
- Hemodynamically comparable to other mechanical valves
- Valve related complications are similar
