# **SNS COLLEGE OF TECHNOLOGY**

**COURSE NAME: 16GE301 Professional Ethics**

**Unit 2– Engineering as Social Experimentation**

**Topic 1: Challenger Case Study**

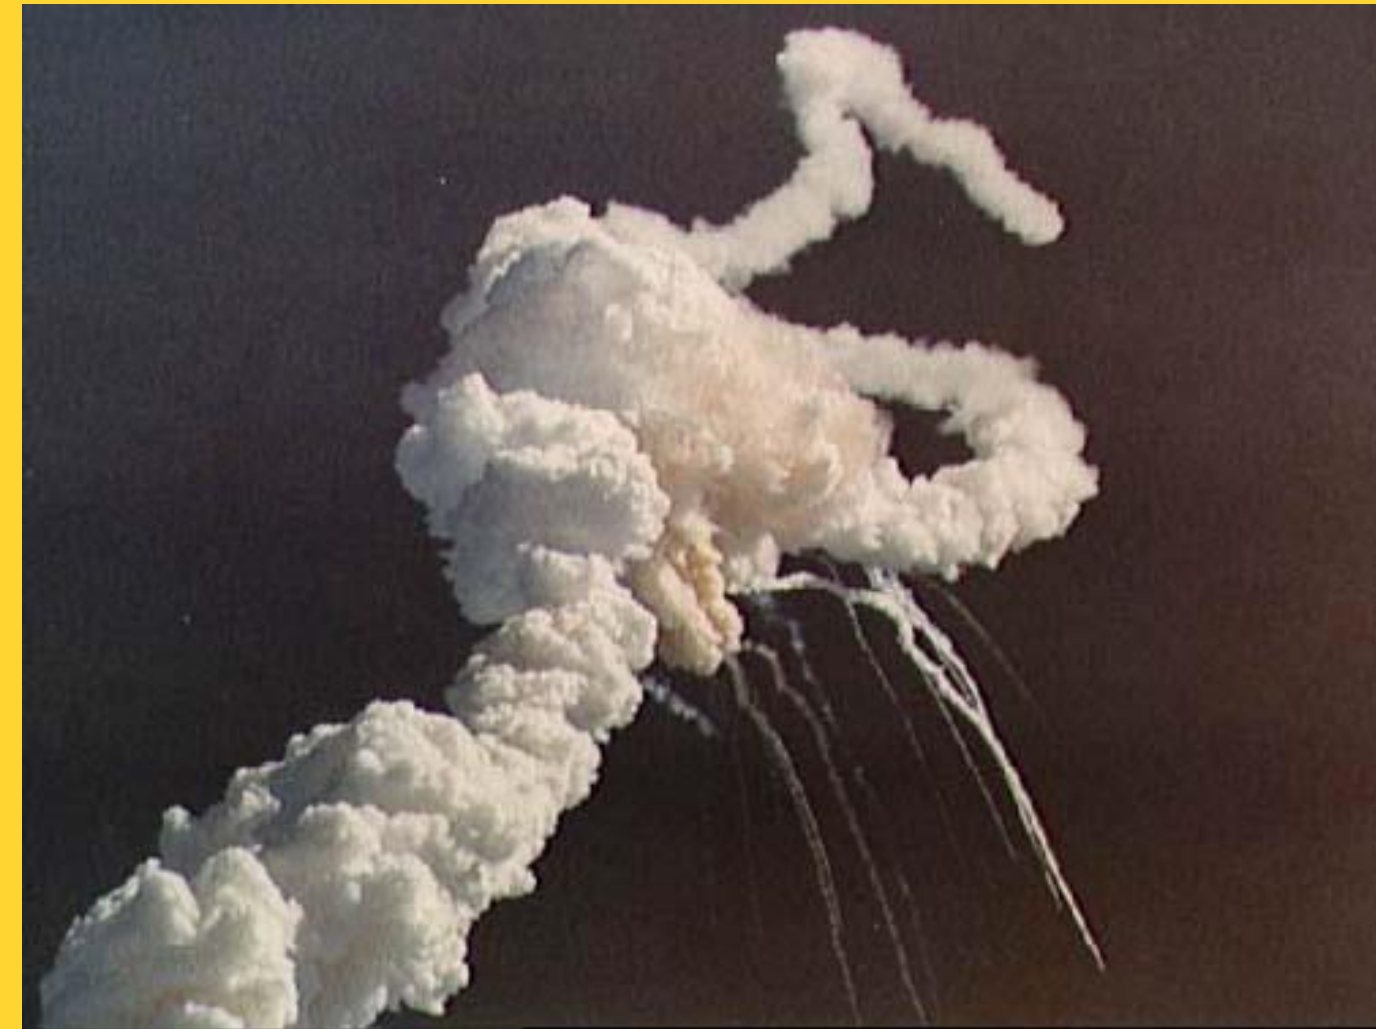
About 80 seconds after Launch  
(shuttle broke down)
