Case study on **JAL -516** crash Jan 2, 2024

DR.M. ELANGOVAN

DEPARTMENT OF AEROSPACE ENGINEERING

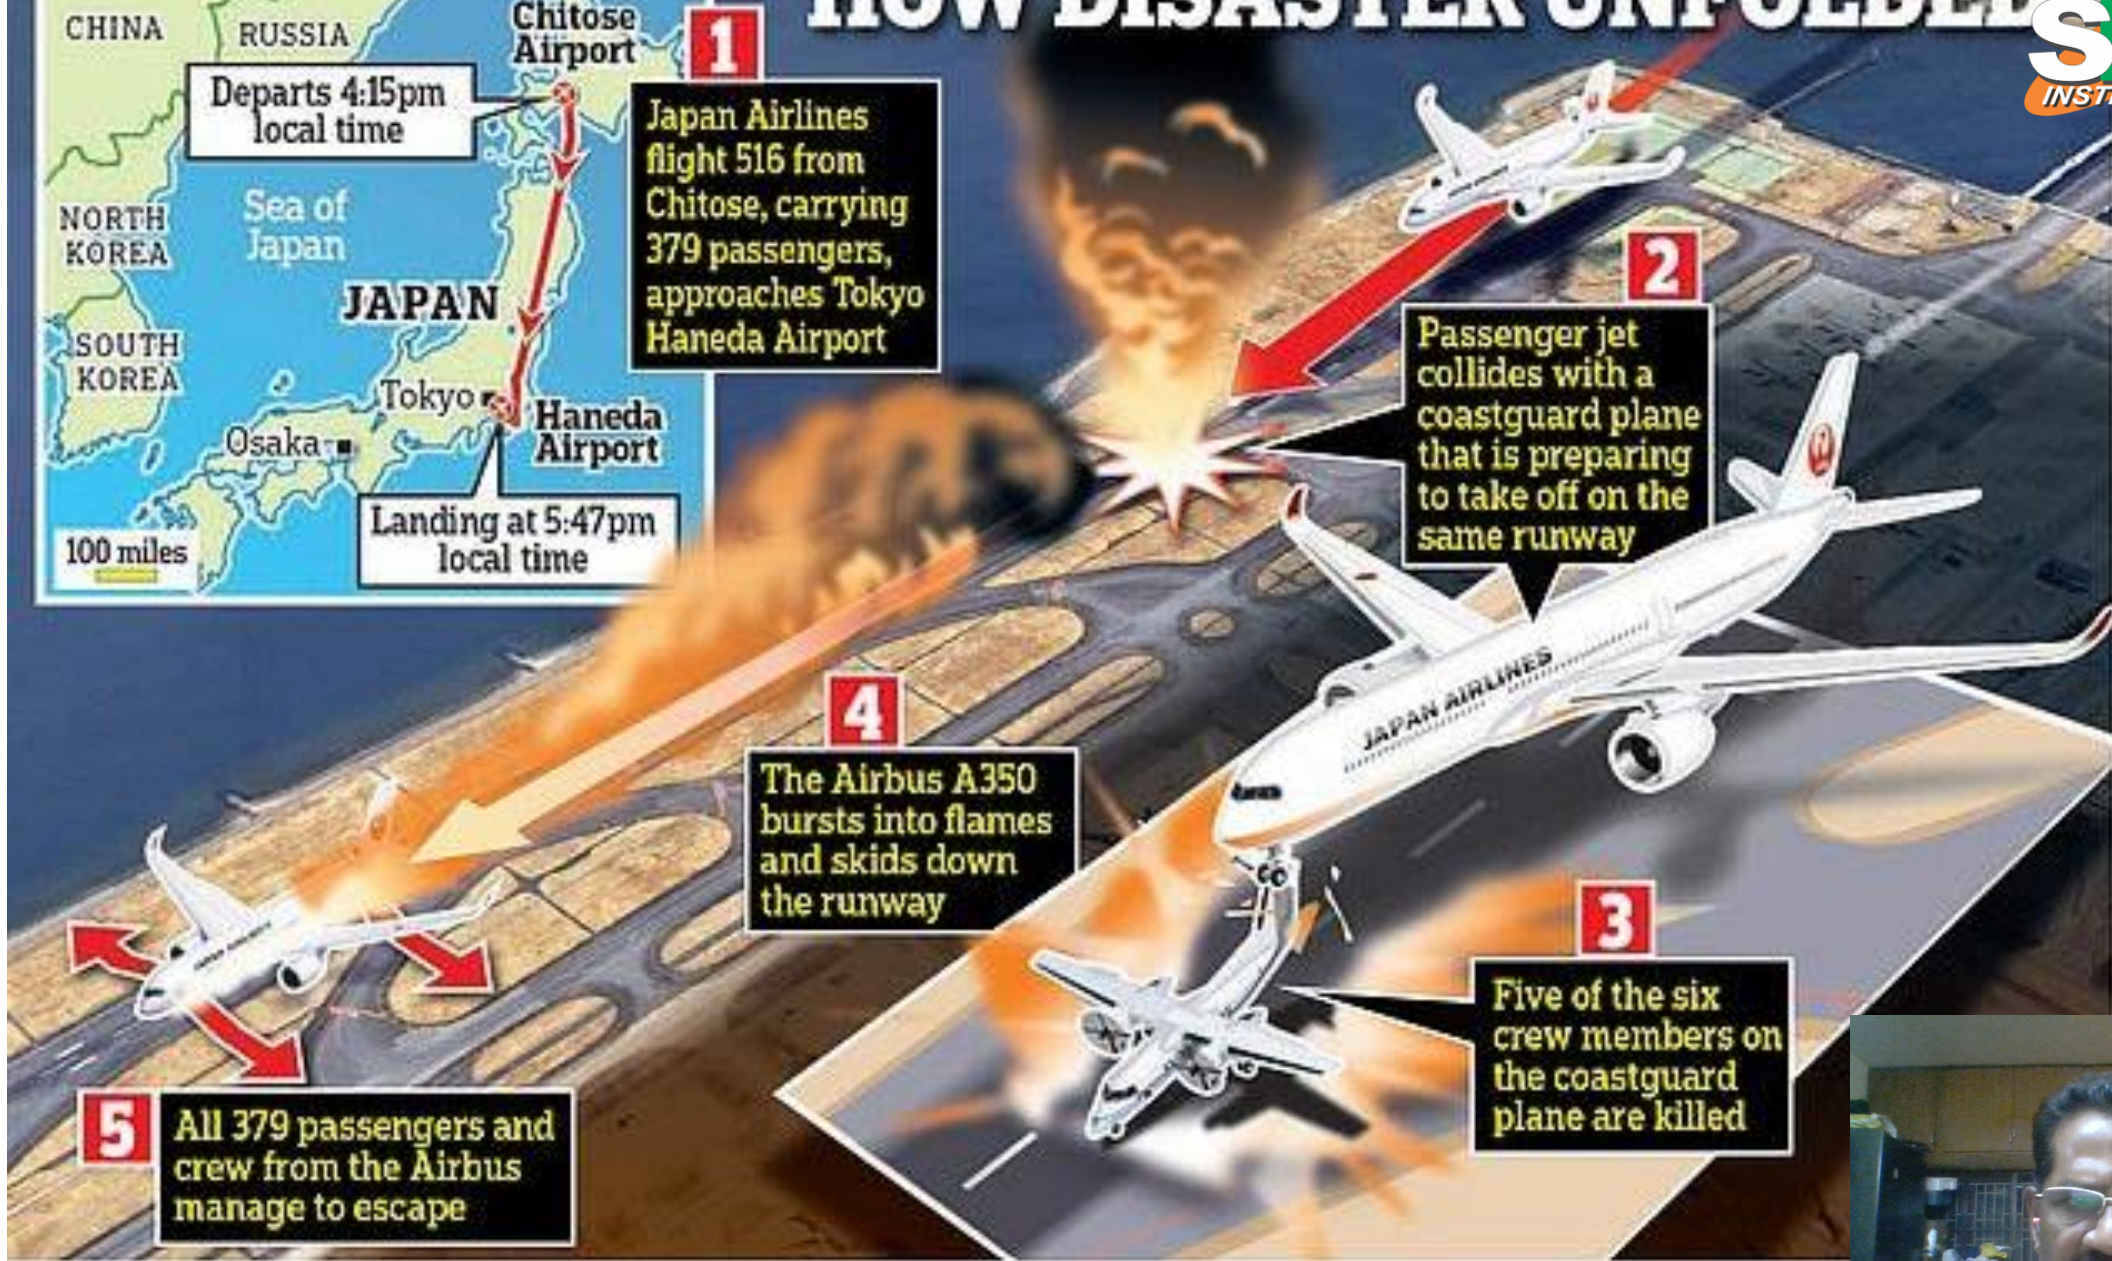
Departs 4:15pm local time

1
Japan Airlines flight 516 from Chitose, carrying 379 passengers, approaches Tokyo Haneda Airport

Landing at 5:47pm local time

4
The Airbus A350 bursts into flames and skids down the runway

2
Passenger jet collides with a coastguard plane that is preparing to take off on the same runway

3
Five of the six crew members on the coastguard plane are killed

5 All 379 passengers and crew from the Airbus manage to escape
